GEOLOGIC ASSESSMENT  
FOR  
REGULATED ACTIVITIES

PROJECT NAME: Harmon Ranch, 1500 Acres, East of Highway 306,  
Comal County, Texas

Project No. AAB98-003-00  
September 11, 1998

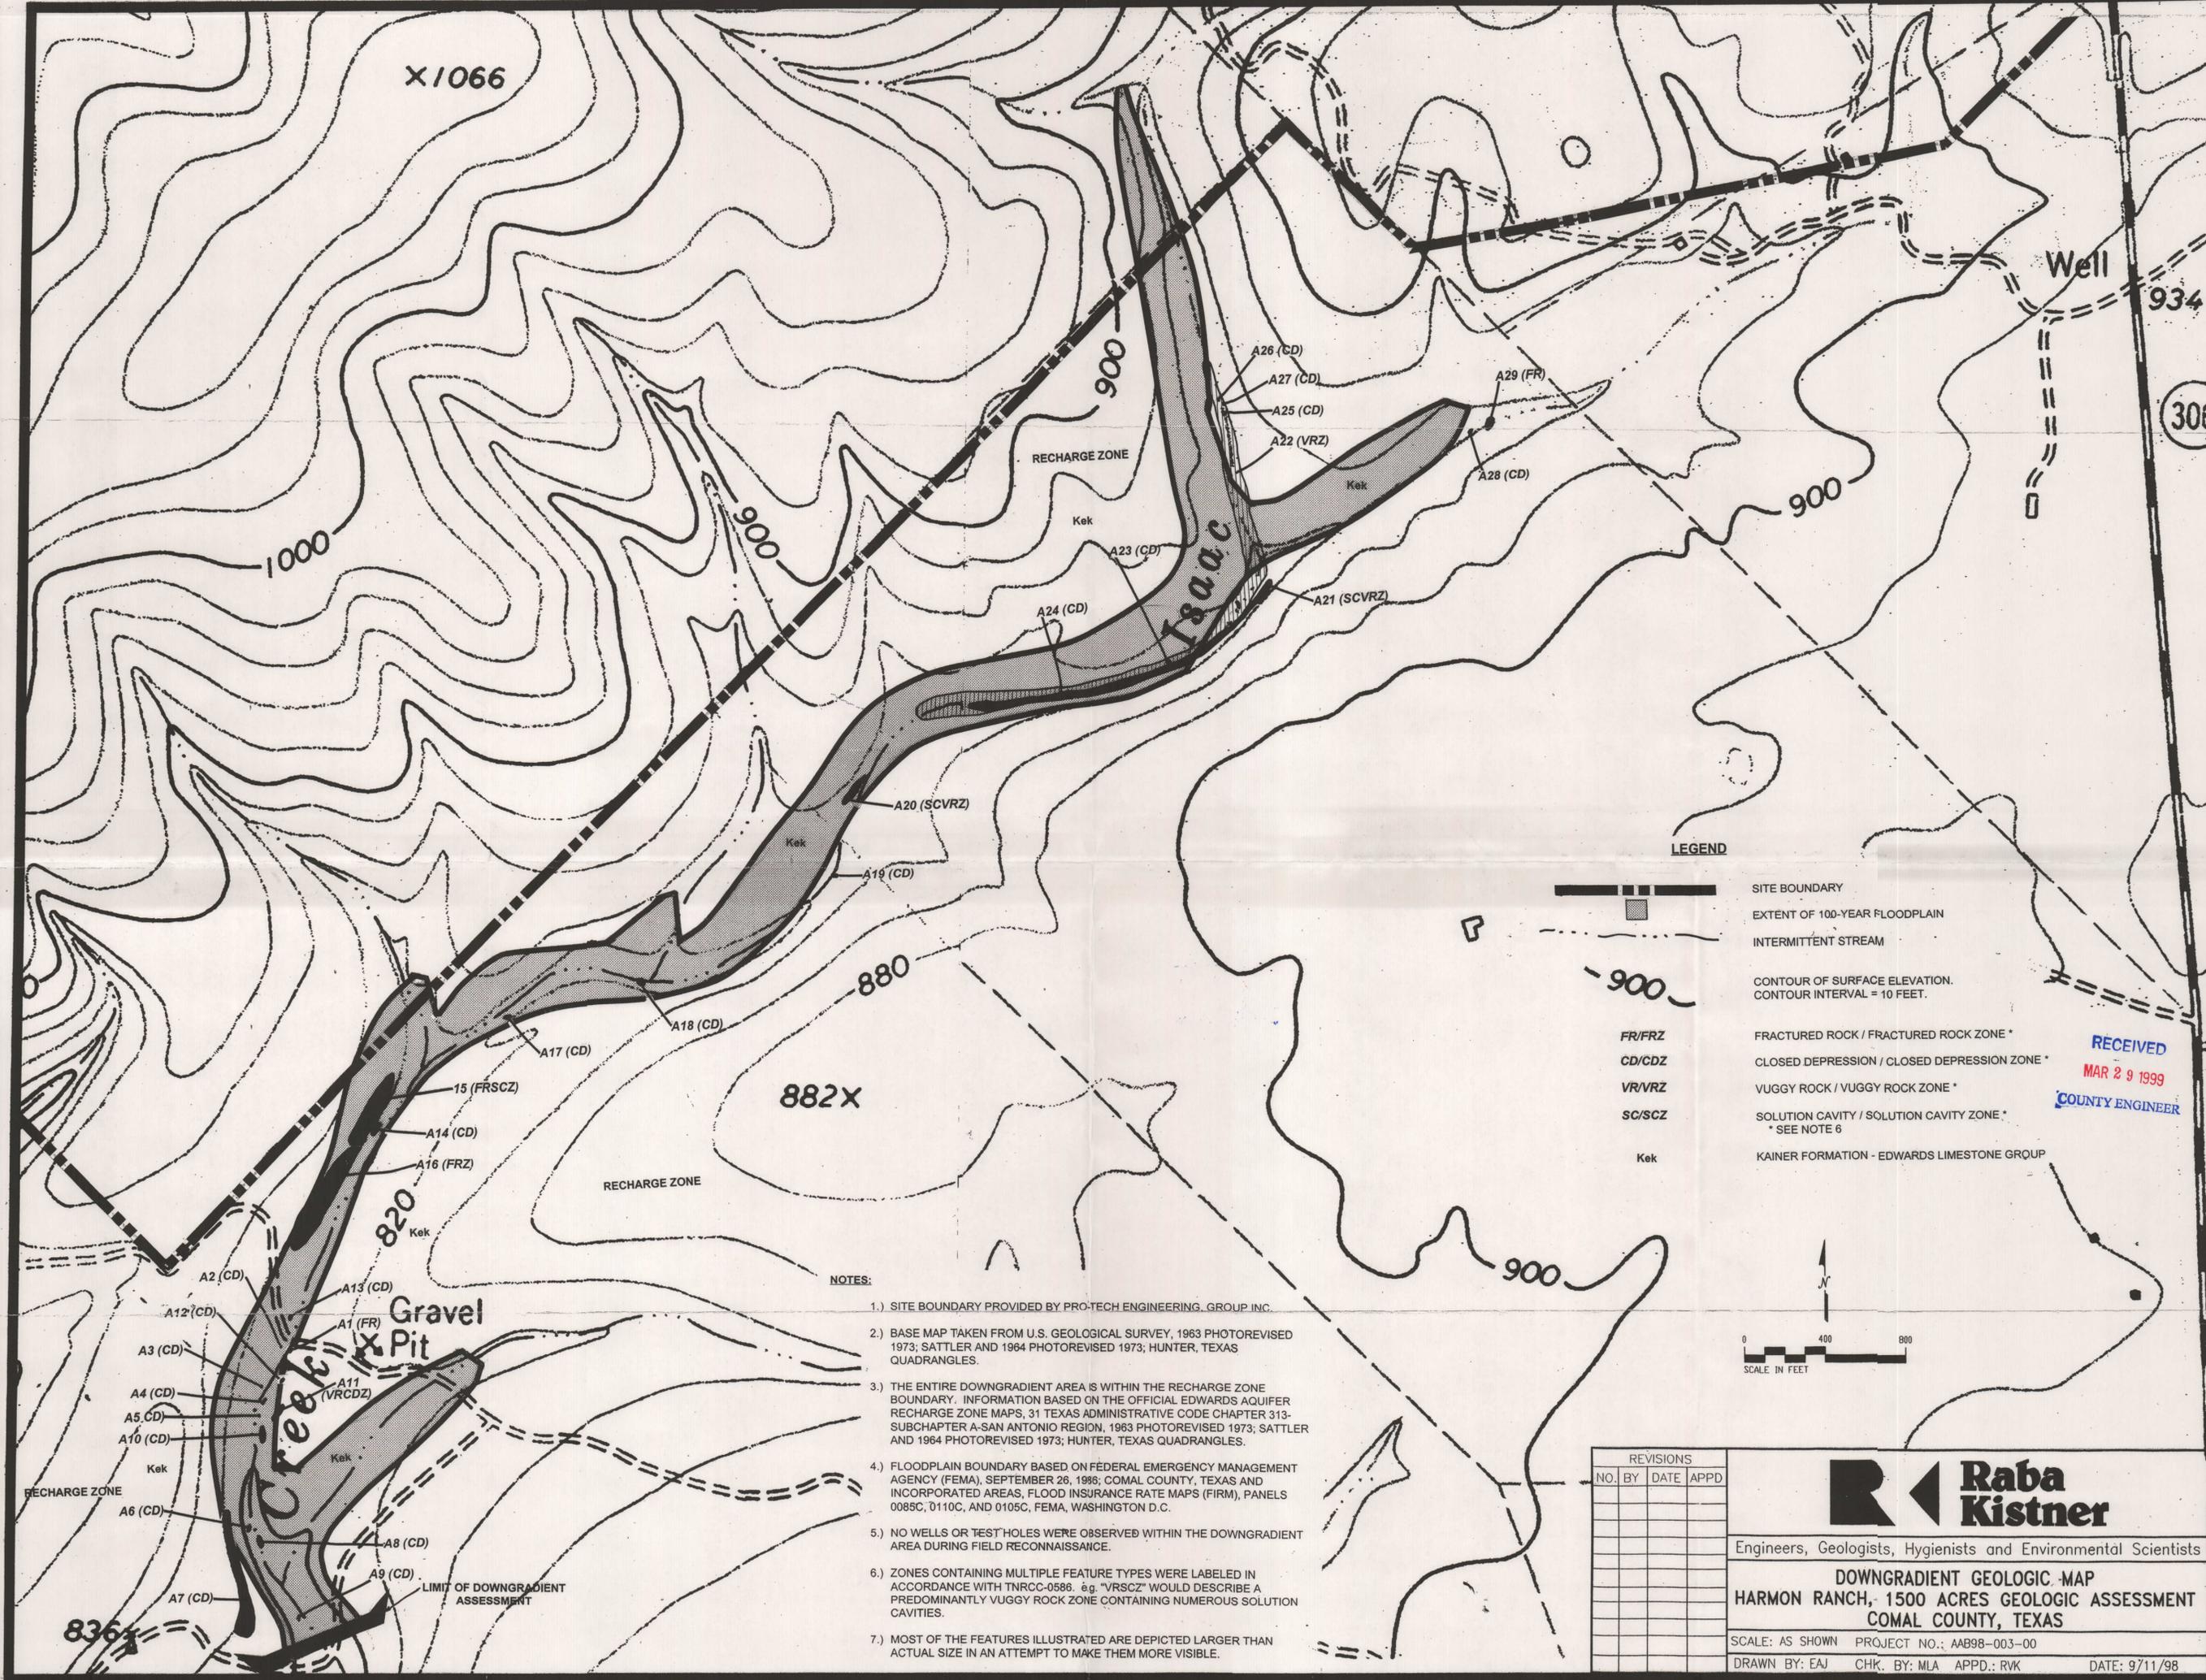
**DOWNGRADIENT GEOLOGIC MAP**  
**HARMON RANCH, 1500 ACRES GEOLOGIC ASSESSMENT**  
**COMAL COUNTY, TEXAS**

~~Three~~ solution cavity zones were identified within the downgradient area of the site along the 100-year floodplain of the Isaac Creek (Downgradient Geologic Map). Individual features within the zones were generally oriented horizontally along bedding planes. Cavities ranged from 1 to 10 feet in length, 1 to 3 feet high, and 1 to 3 feet deep. These features are ranked as sensitive, having moderate to high potential of transmitting fluids to the Edwards Aquifer.

Three vuggy rock zones (A-11 and A-20 through A-23) were identified within downgradient drainage area assessed during this investigation (Downgradient Geologic Map). These features are ranked as potentially, having high potential of transmitting fluids to the Edwards Aquifer.

As shown on the Downgradient Geologic Map, twenty closed depressions were identified within the downgradient drainage areas associated with this site. The majority of features, located within the Isaac Creek 100-year floodplain, were typically infilled with fine-grained materials. Based upon TNRCC-0586 criteria and professional judgment, all closed depressions within the 100-year flood plain were ranked as being not sensitive recharge features, having high potential of transmitting fluids to the Edwards Aquifer.

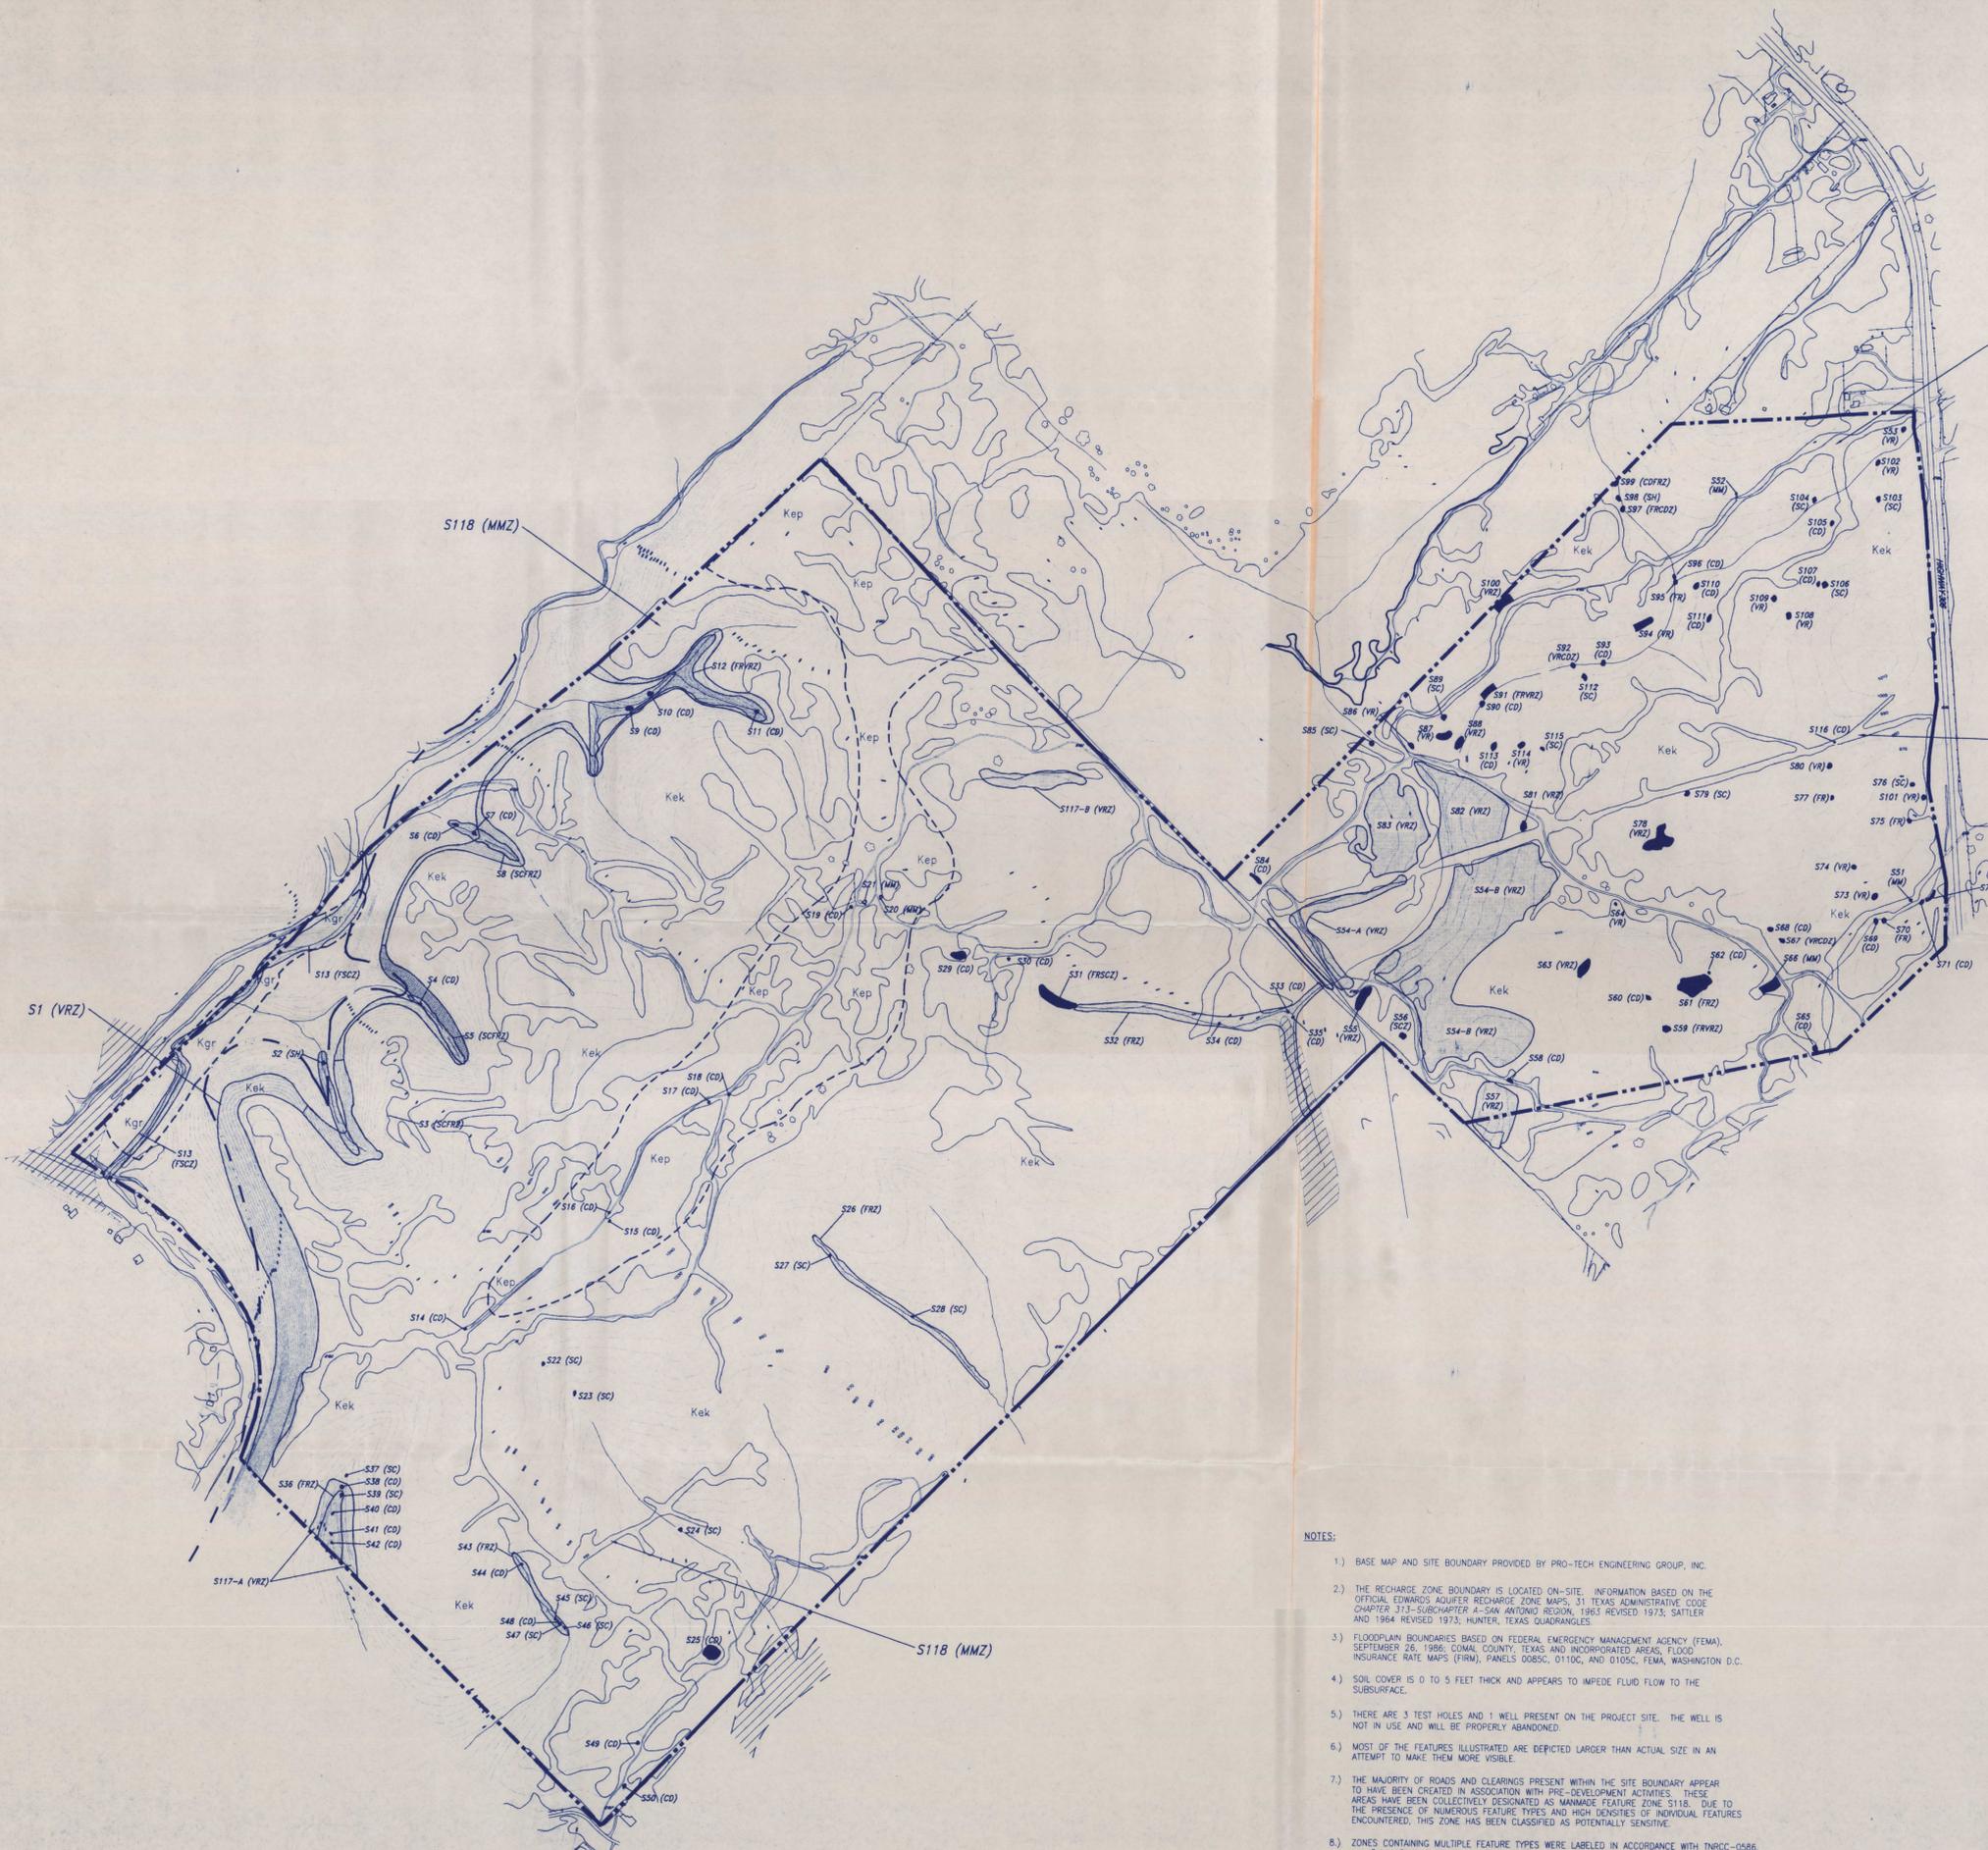
Two sinkholes were identified on the project site. Feature S-2 was located in the streambed of the westernmost branch of Deep creek. The feature is partially enclosed by alluvium though water was not observed at the time of field reconnaissance. The feature appears to have been enhanced by scour from surface runoff. This feature was ranked as sensitive, having high potential for transmitting fluids to the Edwards Aquifer.

Feature S-98 was identified in the drainage located on the northwest portion of the project site. The feature contained coarse infilling and was ranked as potentially sensitive, having high potential for recharge.

As shown on the Site Geologic Map, five man-made features were identified within site boundaries that may serve to enhance the transmission of surface runoff into the Edwards Aquifer. Features S-20, S-51, and S-52 are 1-ft diameter exploratory holes. The depth to which these features extend into the subsurface is unknown and it is unknown whether the bases of these borings are plugged with impermeable material such as concrete. Assuming these features to be unplugged, they were classified as sensitive, having high potential for transmitting fluids into the Edwards Aquifer.

Feature S-21 is an agricultural water well located on the project site. The depth and condition of this well is unknown. It is also unknown whether this well is still operational. Since this well has not been properly abandoned, it was classified as sensitive, having high potential for transmitting fluids into the Edwards Aquifer.
