## TEXAS NATURAL RESOURCE CONSERVATION COMMISSION

NAME OF PROJECT: River Chase Unit-4; Project is located approximately 2.5 miles south of Purgatory Road on F.M. 306; New Braunfels, Texas

TYPE OF PLAN: Request for Approval of a Water Pollution Abatement Plan (WPAP); 30 Texas Administrative Code (TAC) Chapter 213 Edwards Aquifer  
Edwards Aquifer Protection Program File No. 1,661.00

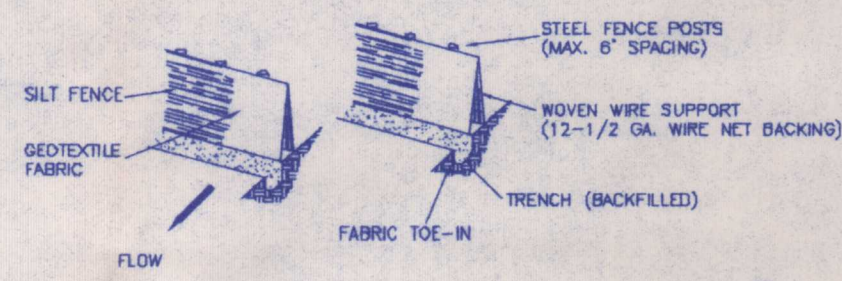
TRENCH CROSS-SECTION

- GENERAL NOTES:
1. STEEL POSTS WHICH SUPPORT THE SILT FENCE SHALL BE INSTALLED ON A SLIGHT ANGLE TOWARD THE ANTICIPATED RUNOFF SOURCE. POST MUST BE EMBEDDED A MINIMUM OF ONE FOOT.

6. SILT FENCE SHALL BE REMOVED WHEN THE SITE IS COMPLETELY STABILIZED SO AS NOT TO BLOCK OR IMPED E STORM FLOW OR DRAINAGE.
  7. ACCUMULATED SILT SHALL BE REMOVED WHEN IT REACHES A DEPTH OF 8 INCHES. THE SILT SHALL BE DISPOSED OF IN AN APPROVED SITE AND IN SUCH A MANNER AS TO NOT CONTRIBUTE TO ADDITIONAL SILTATION.

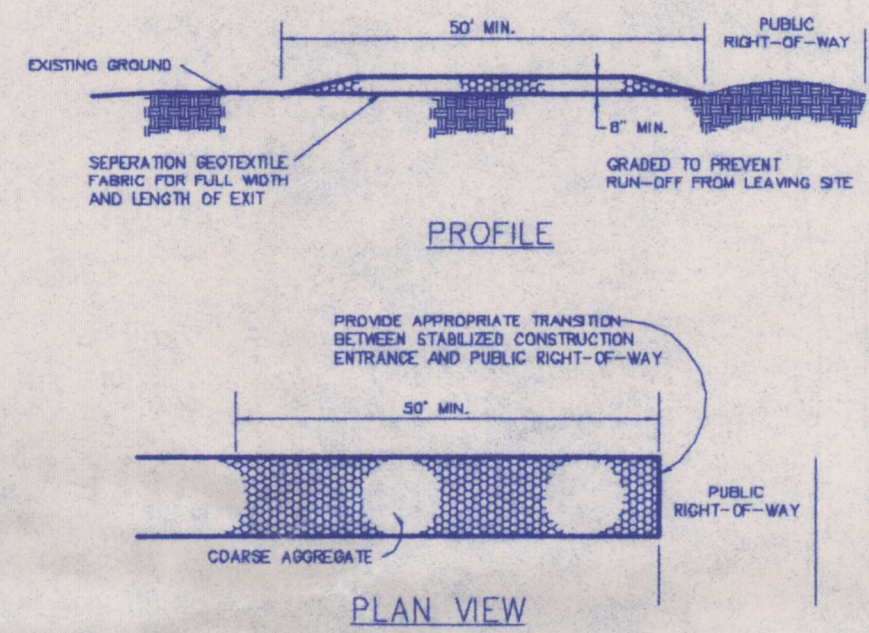
- GENERAL NOTES:
1. Stone size unless otherwise specified, aggregate shall conform to Grade 1 for coarse aggregates under Specification No. 403 "Concrete for Structures".

2. Length as effective, but not less than 100 feet.
  3. Thickness not less than eight (8) inches.
  4. Width not less than full width of all points of ingress or egress.
